6.5 FURNITURE, FIXTURES, EQUIPMENT AND CONTENTS

6.5.2 BOOKCASES, SHELVING

6.5.2.1 BOOKSHELVES

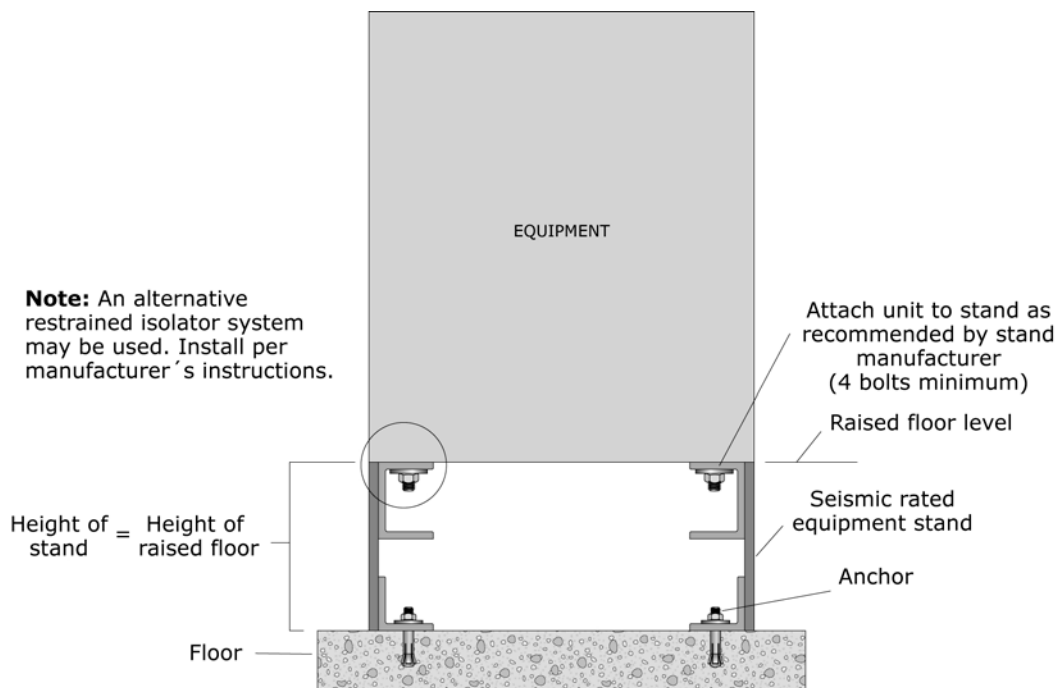
Equipment installed on an independent steel platform within a raised floor

Figure 6.5.3.1-10 Equipment mounted on access floor - independent base (ER).

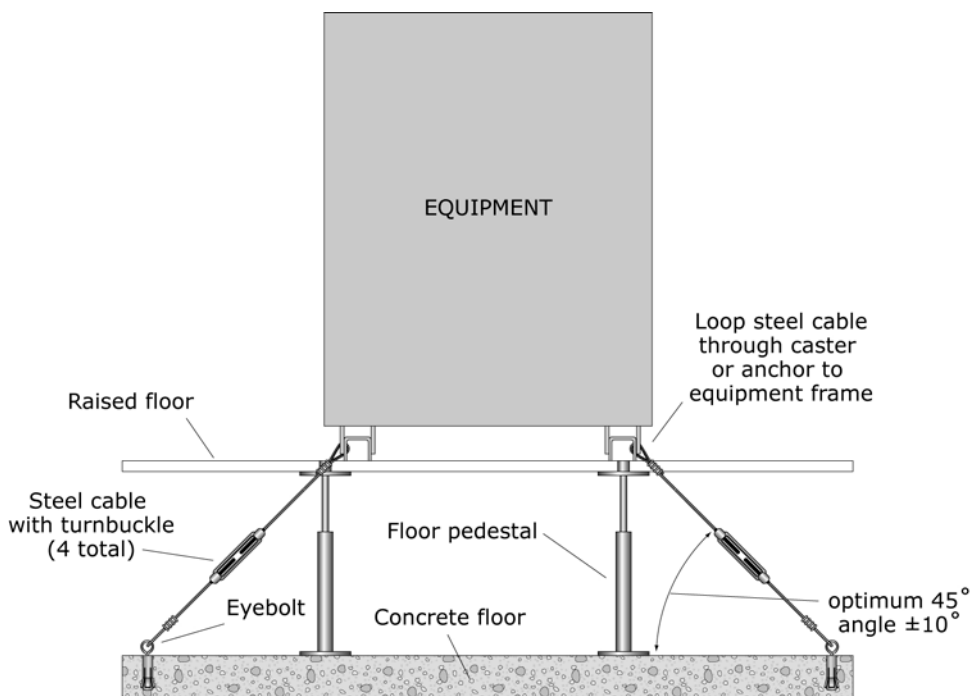
Equipment restrained with cables beneath a raised floor

Figure 6.5.3.1-11 Equipment mounted on access floor – cable braced (ER).

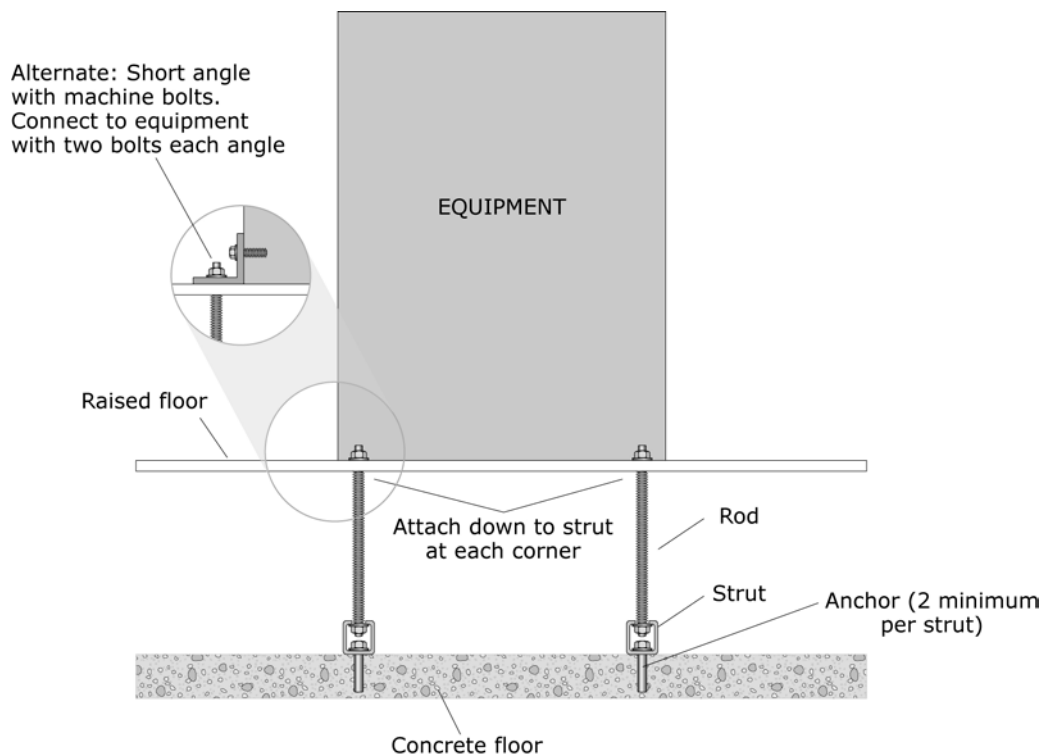
Equipment anchored with vertical rods beneath a raised floor

Figure 6.5.3.1-12 Equipment mounted on access floor – tiedown rods (ER).

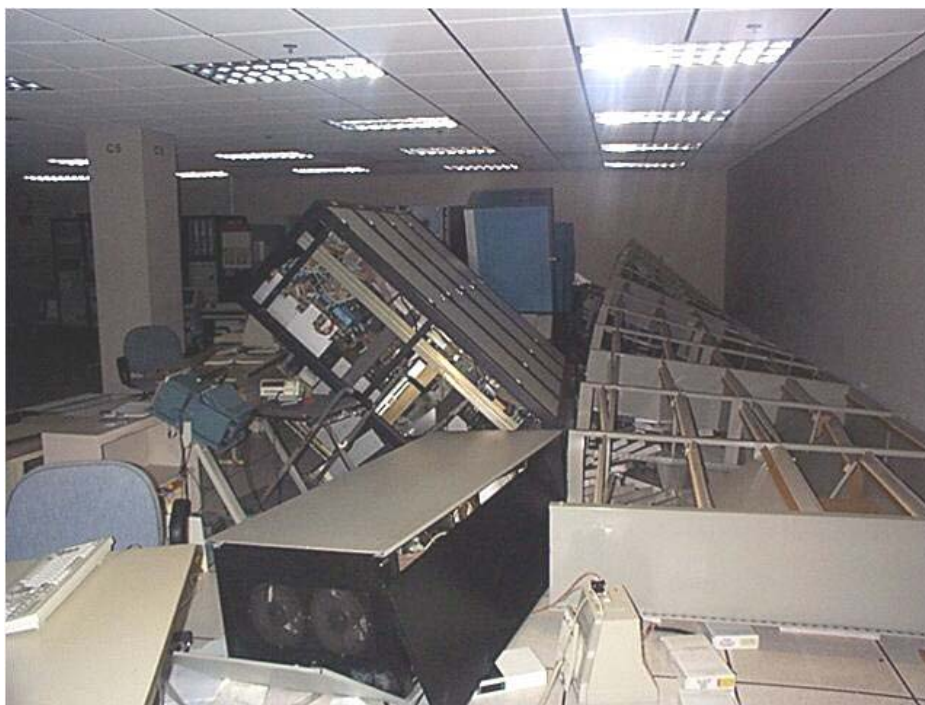
Figure 6.5.3.2-1 Damage to communication and computer racks (Photo courtesy of Degenkolb Engineers).

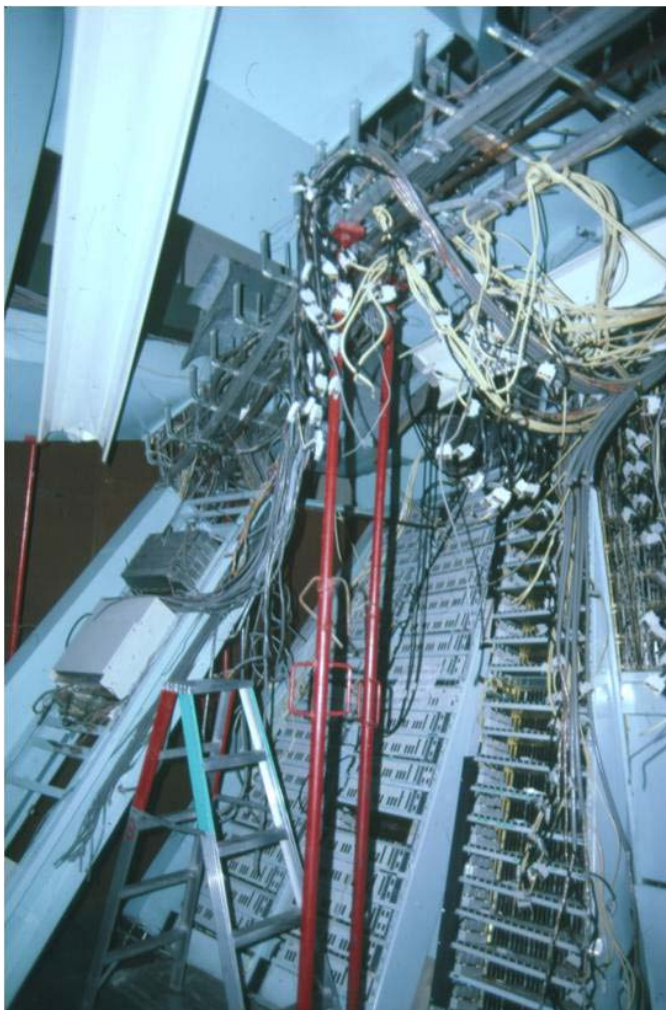
Figure 6.5.3.2-2 Damage to communication and computer racks (Photo courtesy of Degenkolb Engineers).

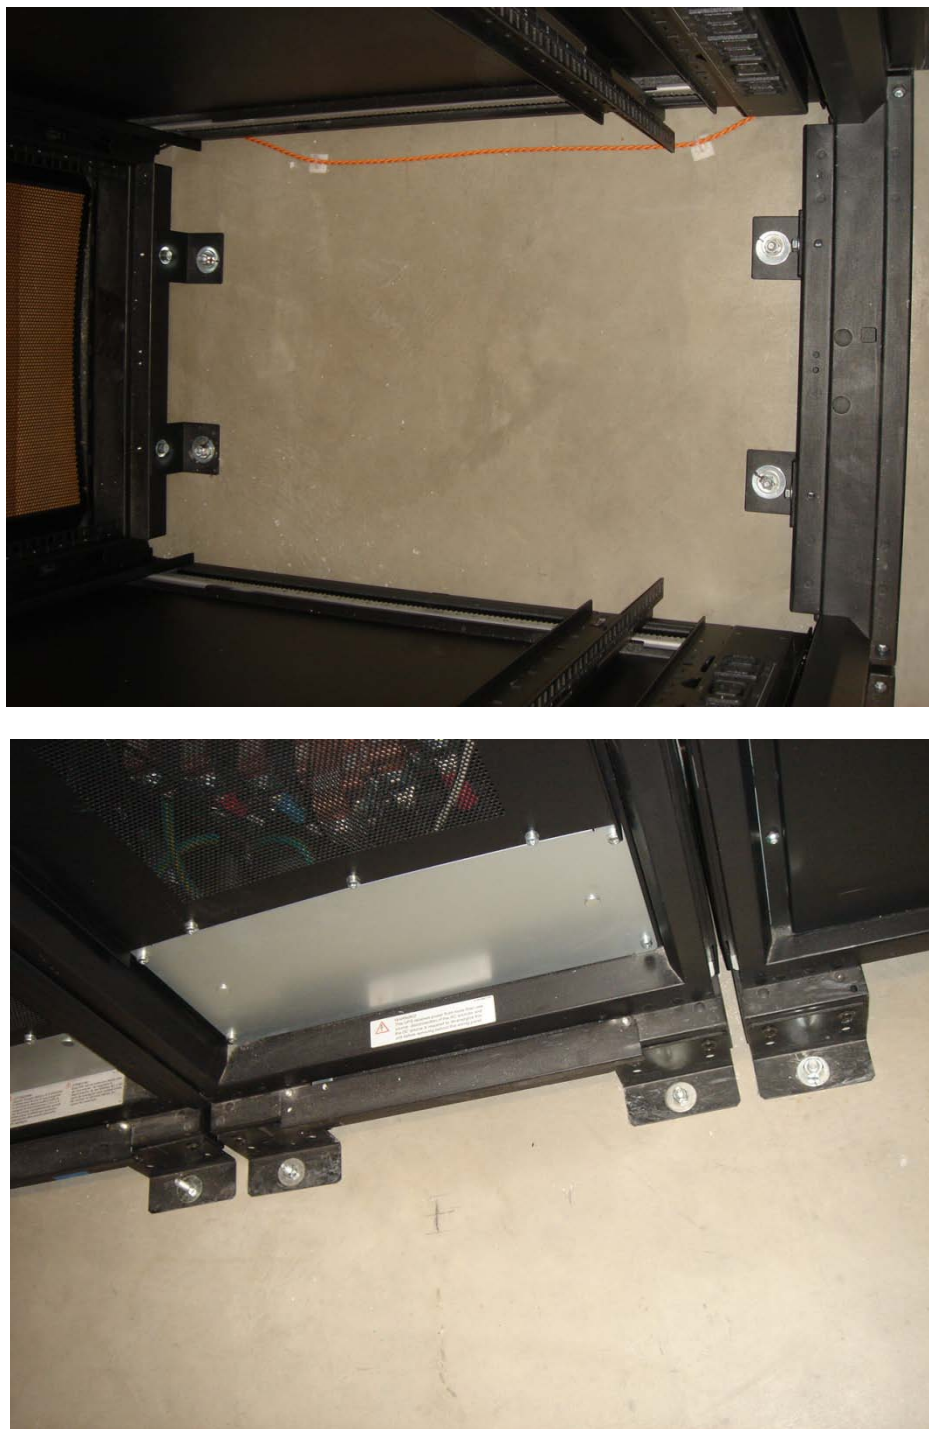
Figure 6.5.3.2-3 Base anchorage details for data cabinets; top photos shows internal anchorage, bottom photo shows external anchorage (Photos courtesy of Maryann Phipps, Estructure).

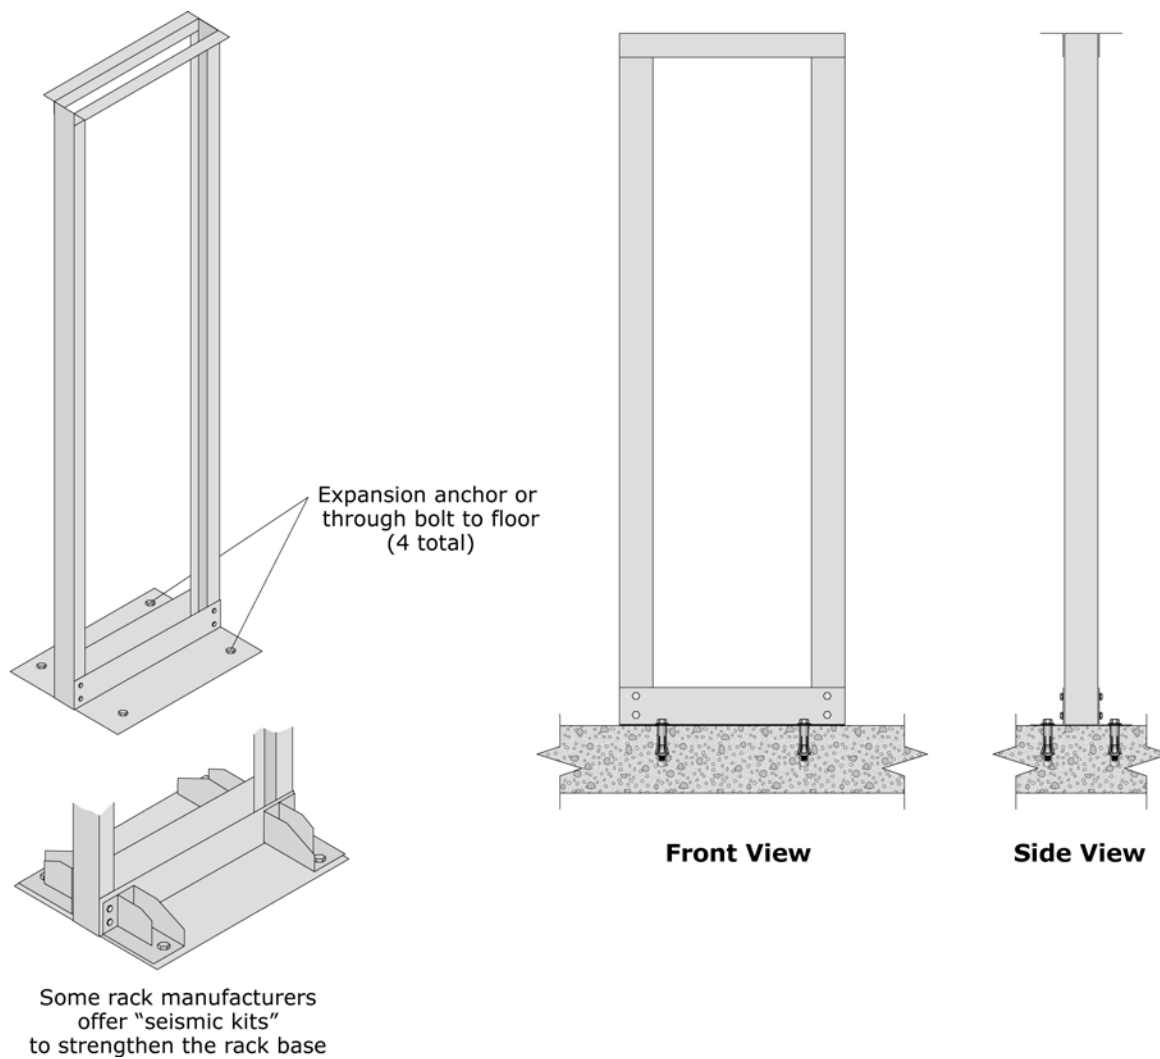
Figure 6.5.3.2-4 Data rack (ER).

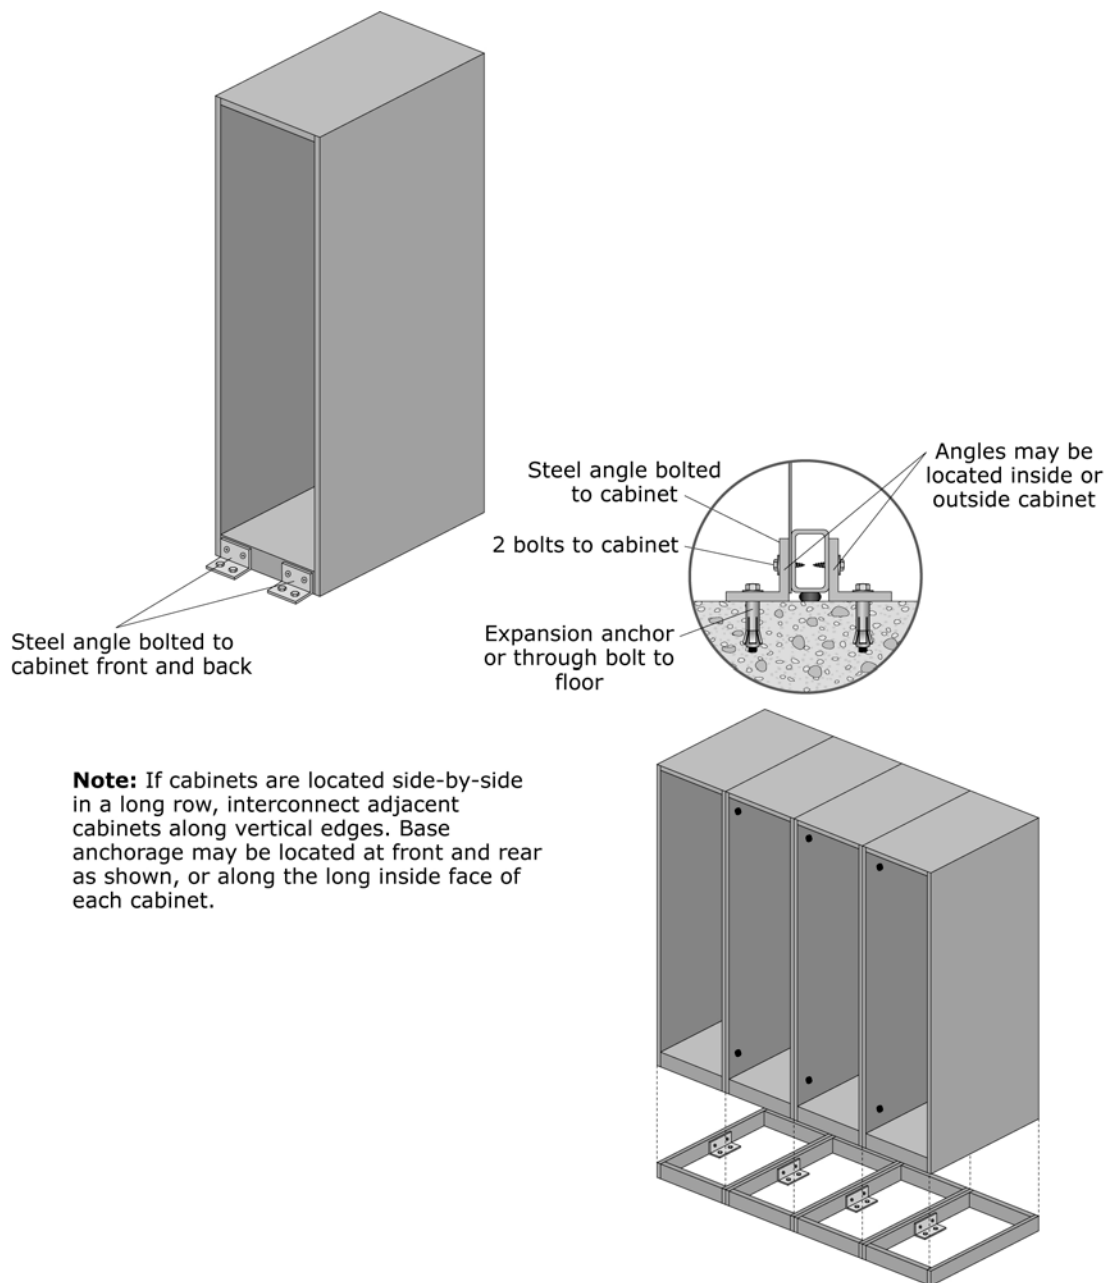
Figure 6.5.3.2-5 Data cabinet (ER).

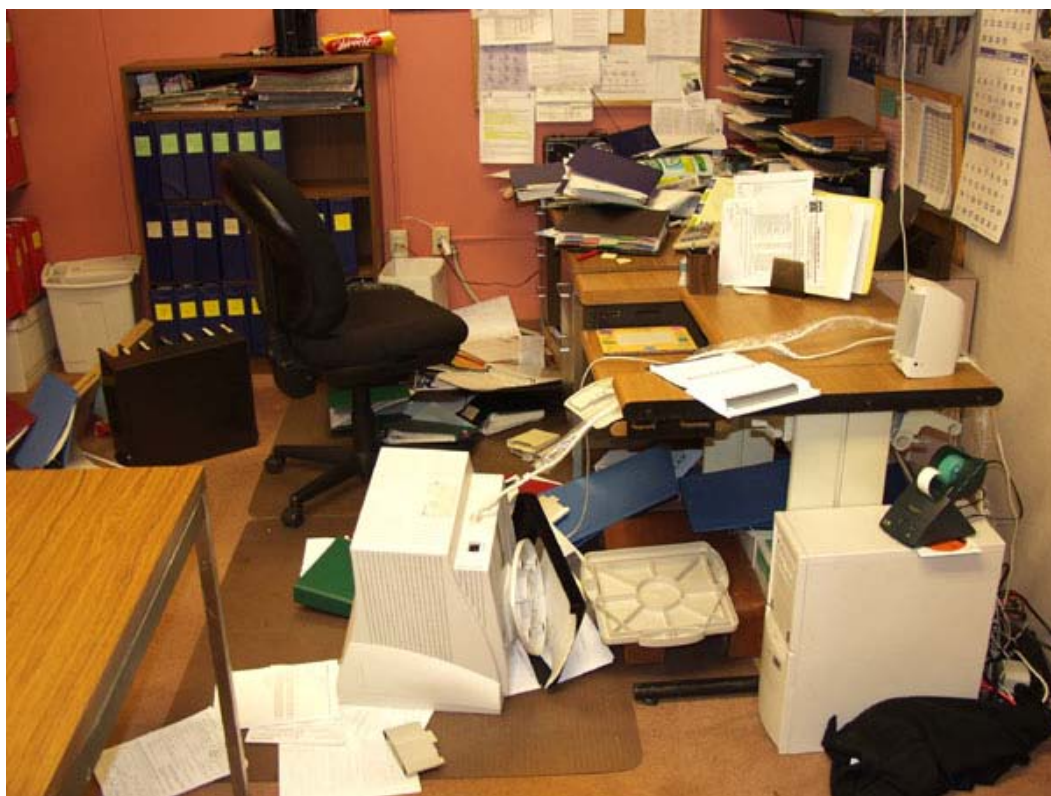
Figure 6.5.3.3-1 Computer monitor slid off desktop onto floor in the 2010 magnitude-6.5 Eureka, California Earthquake (Photo courtesy of Steve Mahin, PEER).

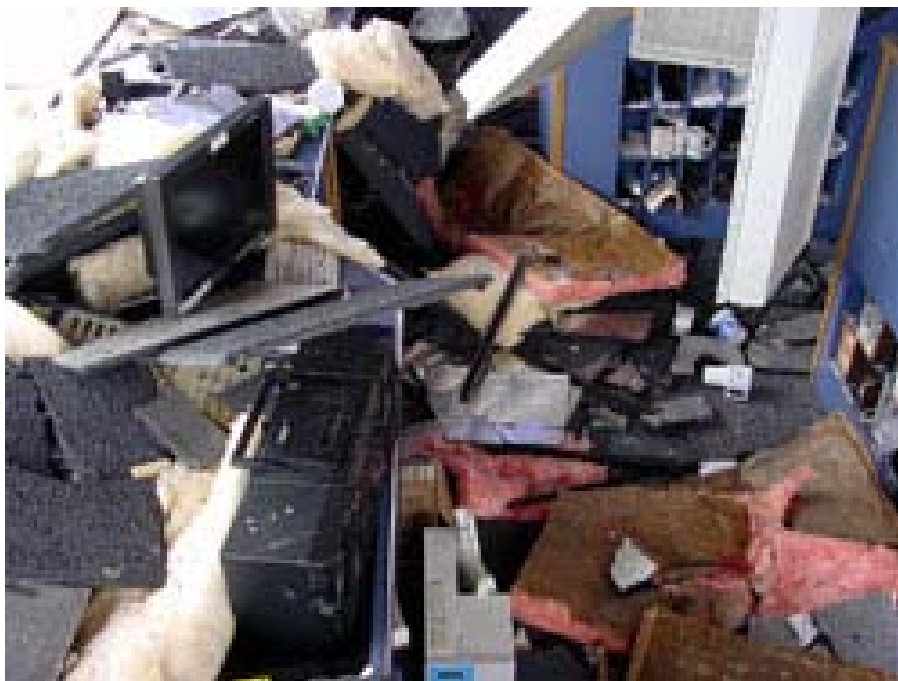
Figure 6.5.3.3-2 Damage to control tower at the SeaTac Airport in the 2001 Nisqually Earthquake (Photo courtesy of JCP Geologists).

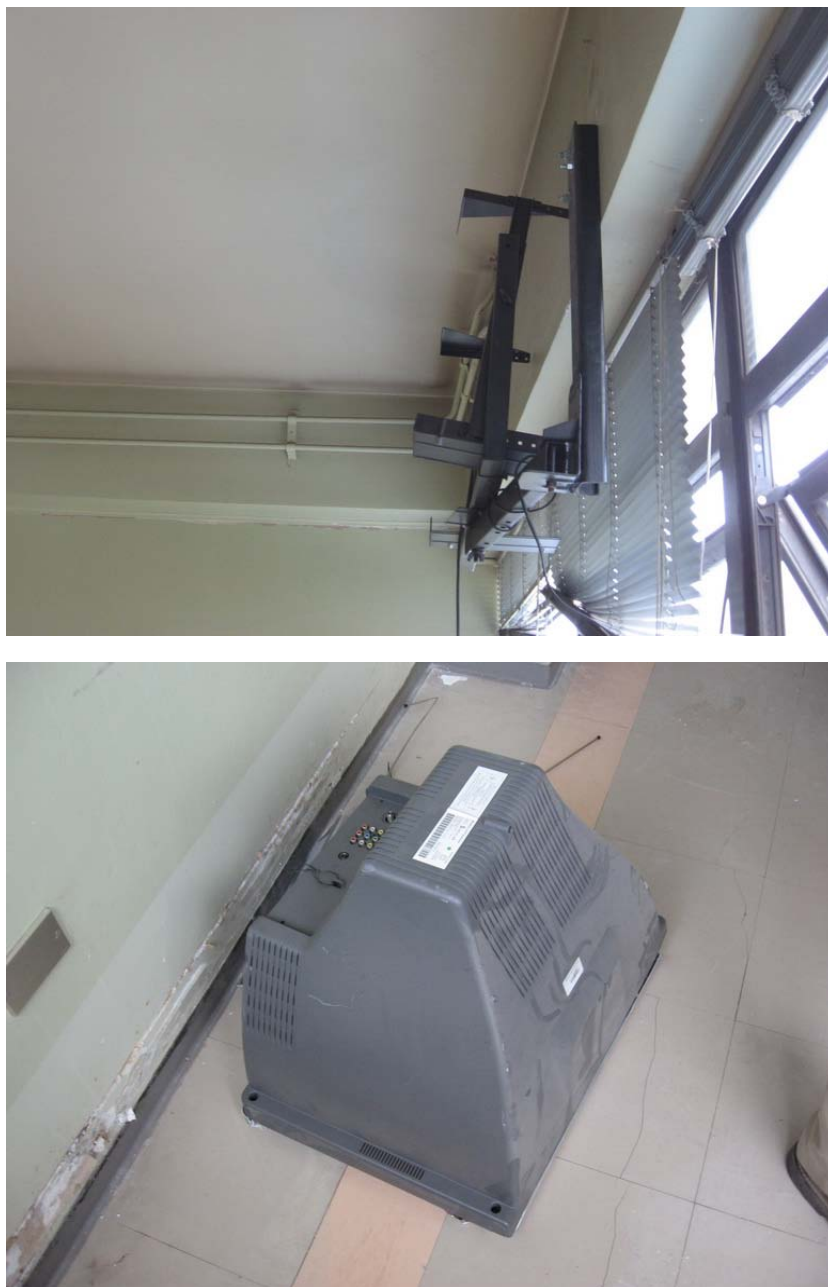
Figure 6.5.3.4-1 Wall-mounted monitor fell from the bracket in a hospital in the 2010 magnitude-8.8 Chile Earthquake; bracket still anchored to the wall (Photos courtesy of Rodrigo Retamales, Rubén Boroschek & Associates)

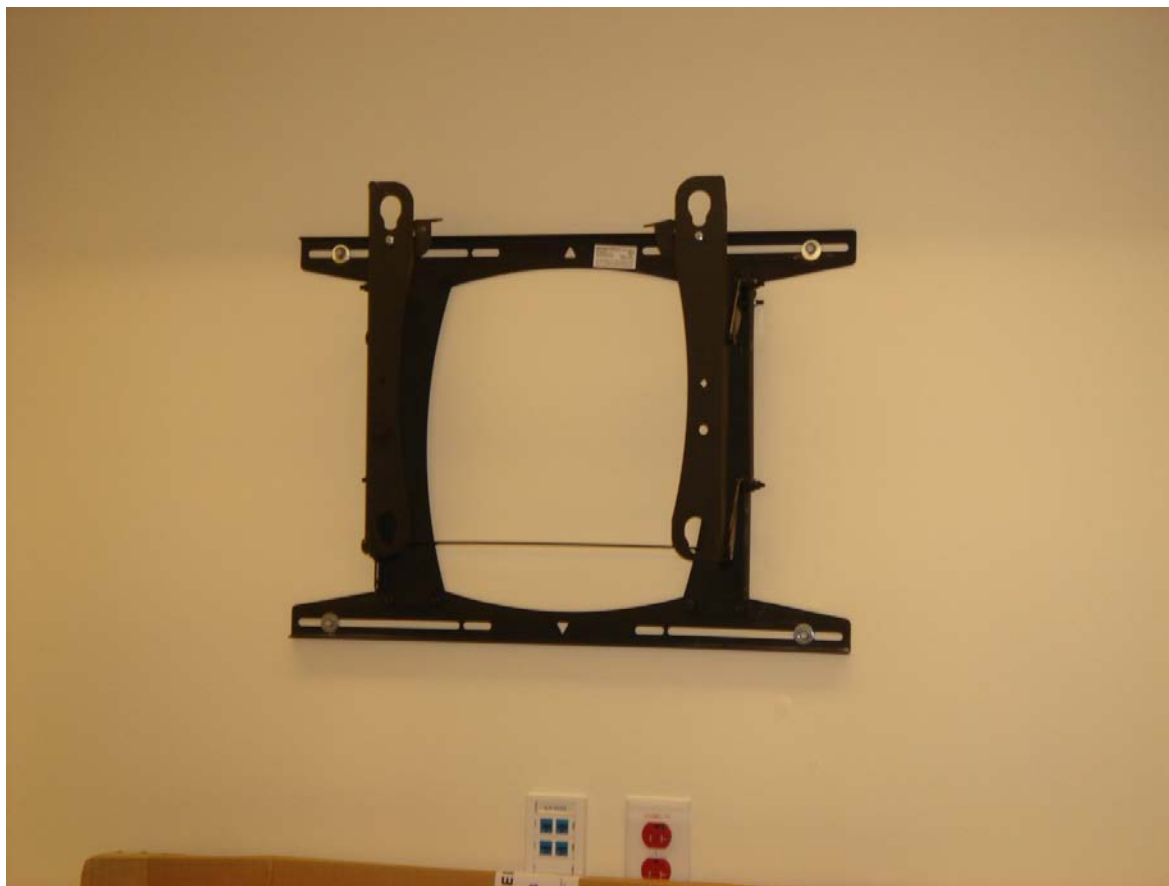
Figure 6.5.3.4-2 Wall-mounted television bracket anchored with sheet metal screws to wall studs at four locations. Bracket must be rated for the weight of television or monitor and that the unit must be securely attached to the bracket (Photo courtesy of Maryann Phipps, Estructure).

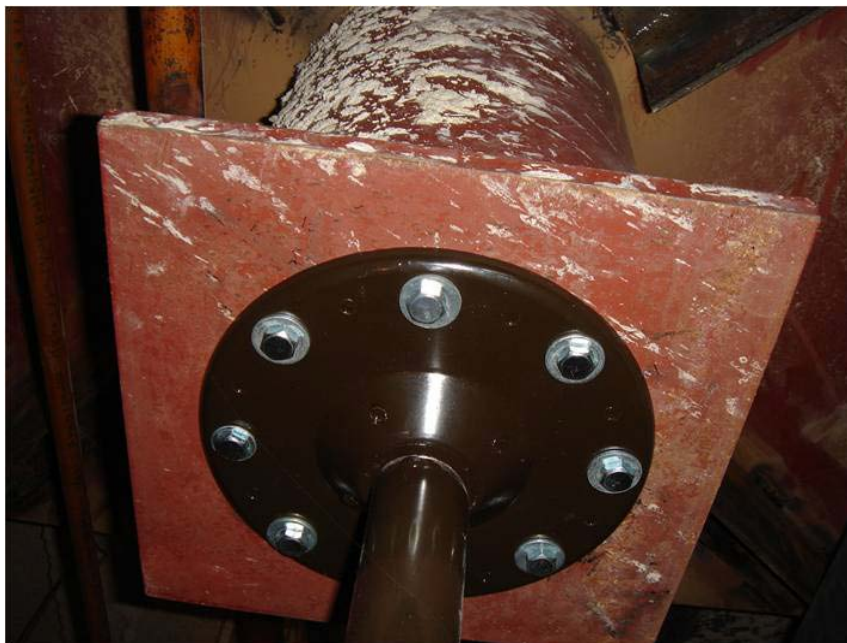
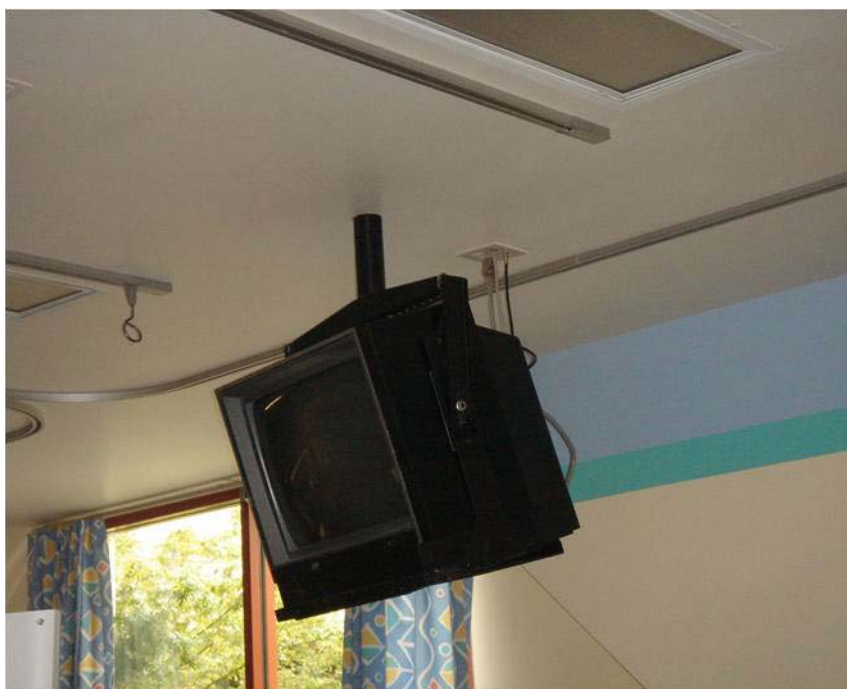
Figure 6.5.3.4-3 Mounting plate above ceiling for overhead television bracket in a hospital room. Television or monitor must be securely attached to the bracket (Photos courtesy of Maryann Phipps, Estructure).

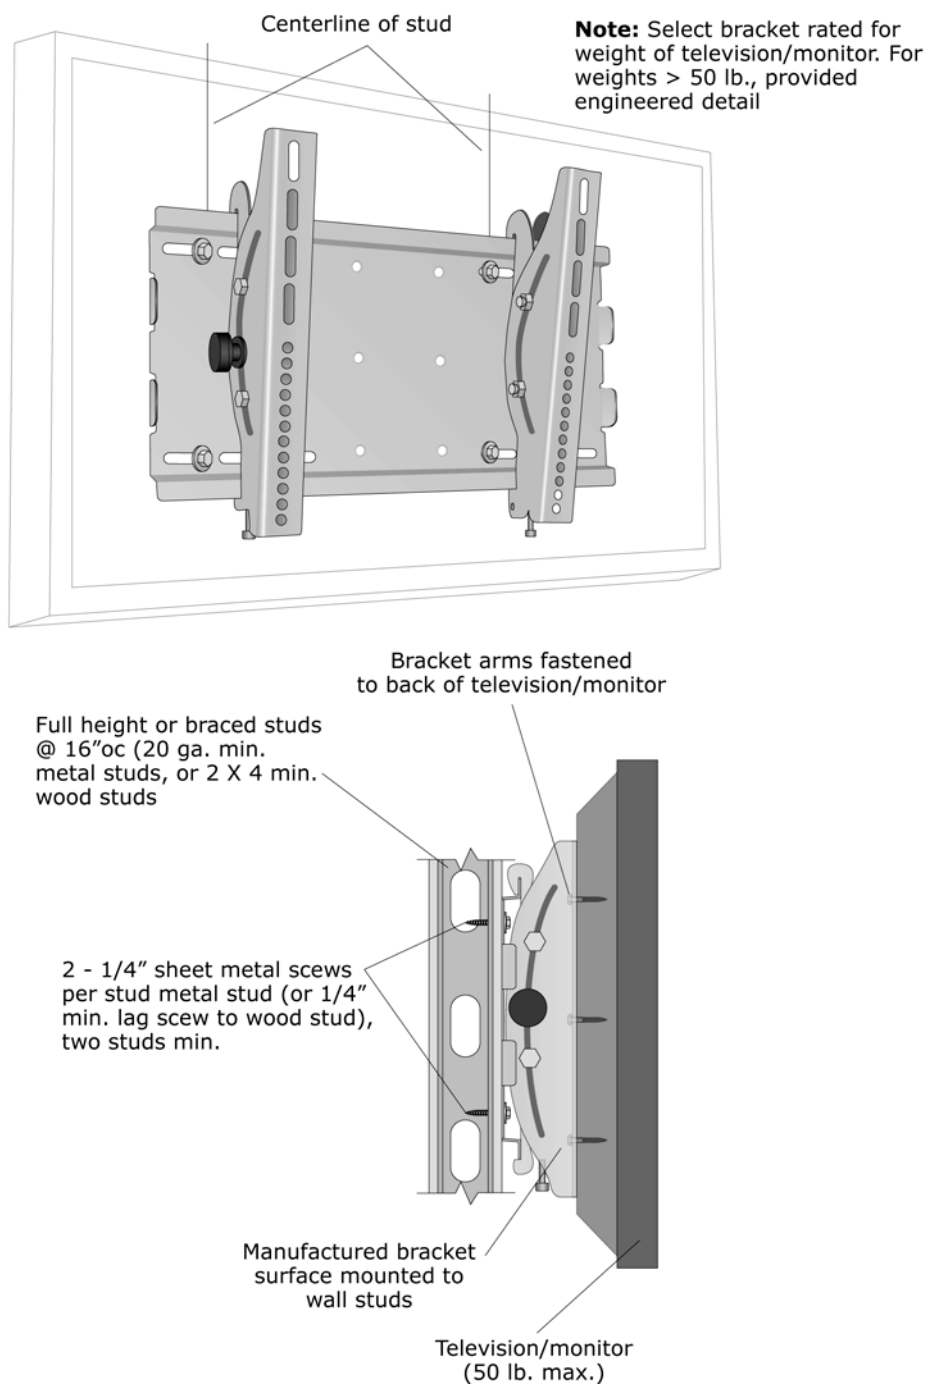
Figure 6.5.3.4-4 Wall-mounted bracket for television or monitor weighing less than 50 lb (NE).

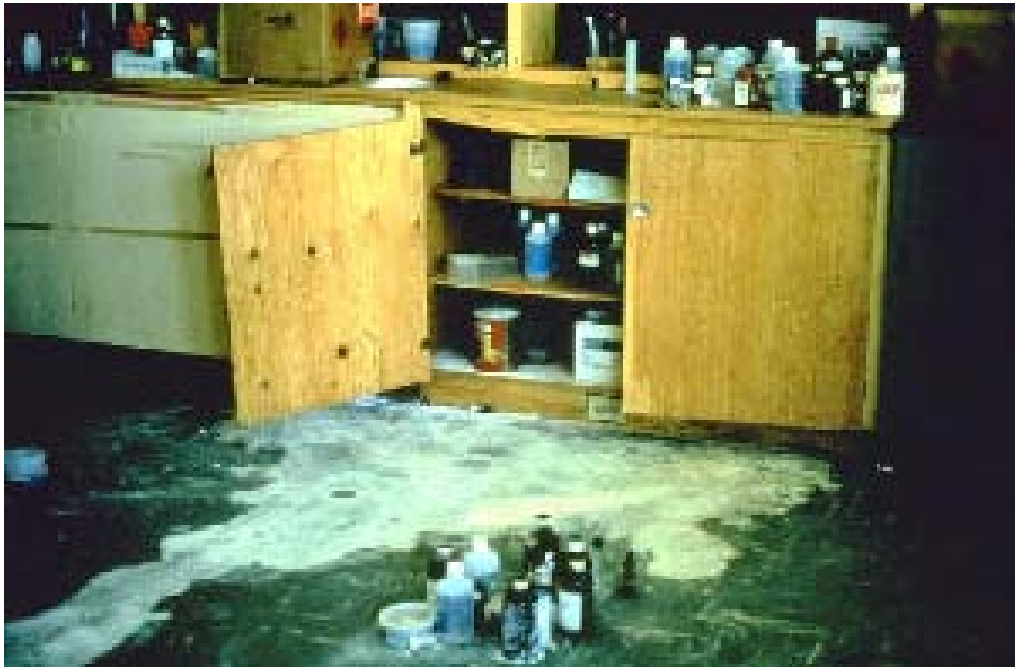
Figure 6.5.4.1-1 Spilled chemicals in high school chemistry lab in the 1971 magnitude-6.6 San Fernando Earthquake (Photo courtesy of EERI).

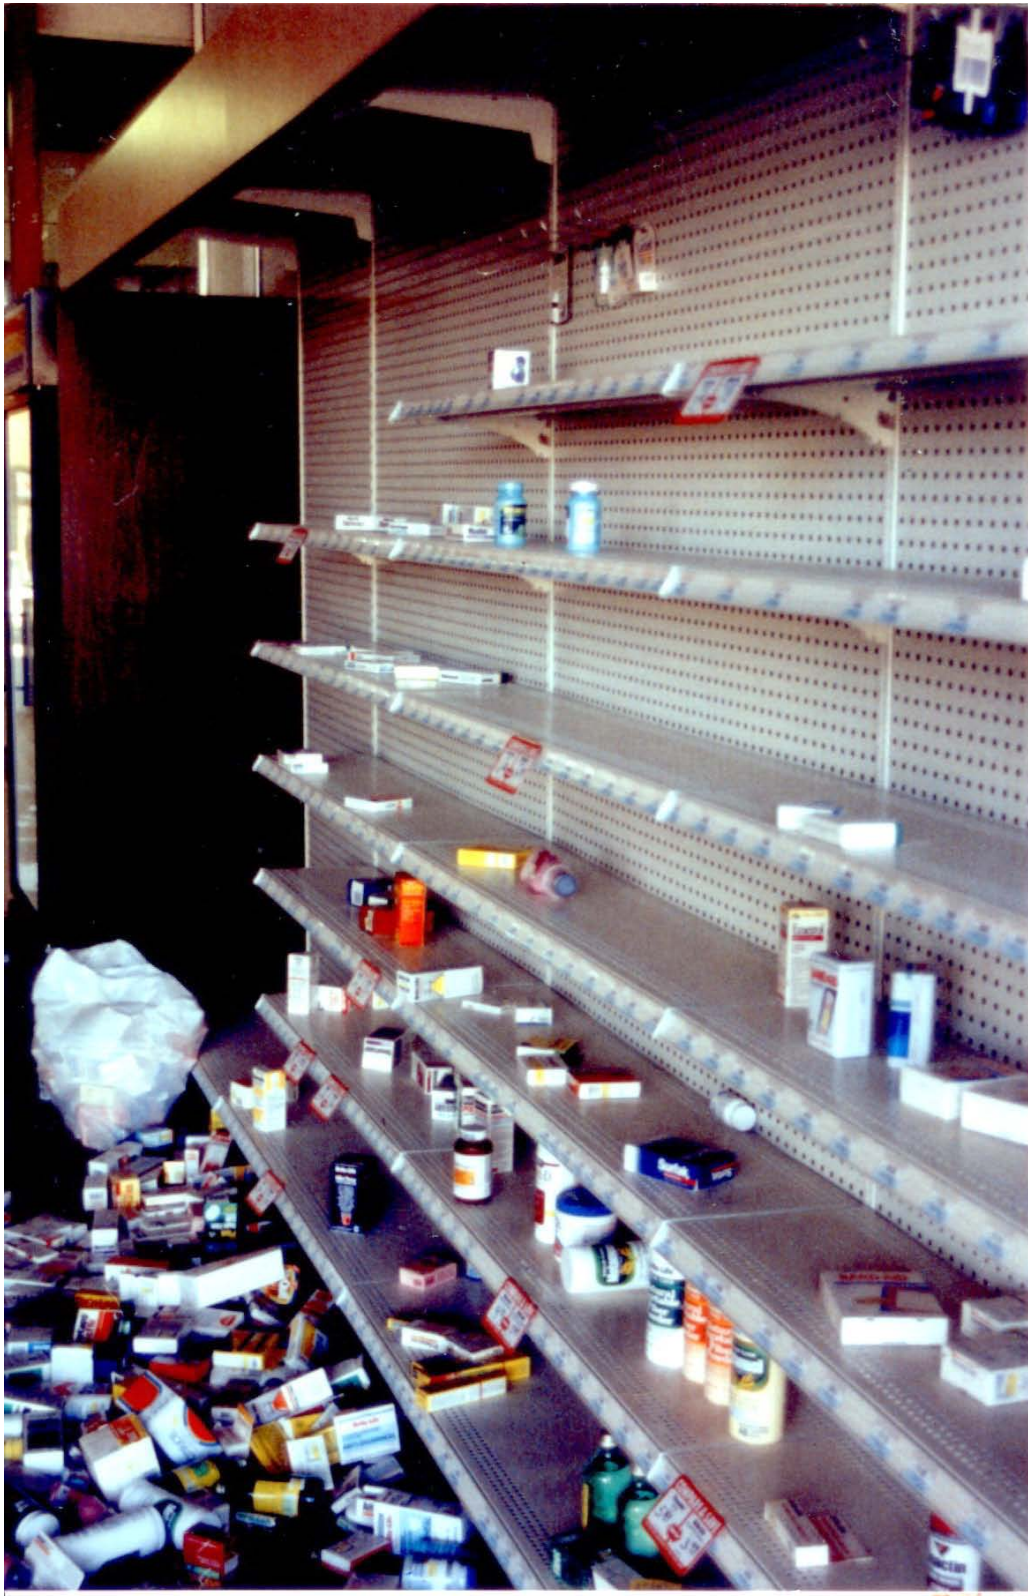
Figure 6.5.4.1-2 Spilled pharmaceutical and medical supplies in the 1994 magnitude-6.7 Northridge Earthquake (Photo courtesy of Robert Reitherman).

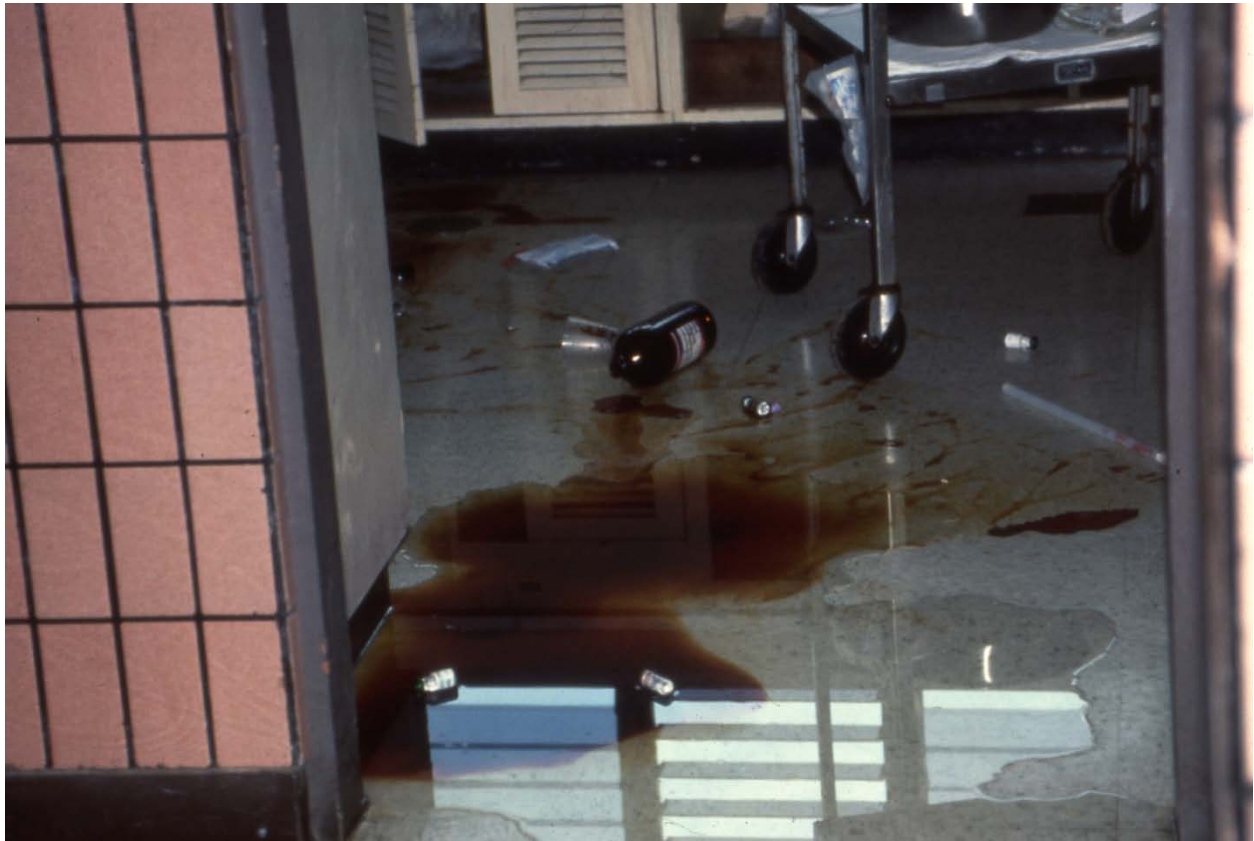
Figure 6.5.4.1-3 Spilled fluids in a hospital in the Costa Rica Earthquake (Photo courtesy of Degenkolb Engineers).

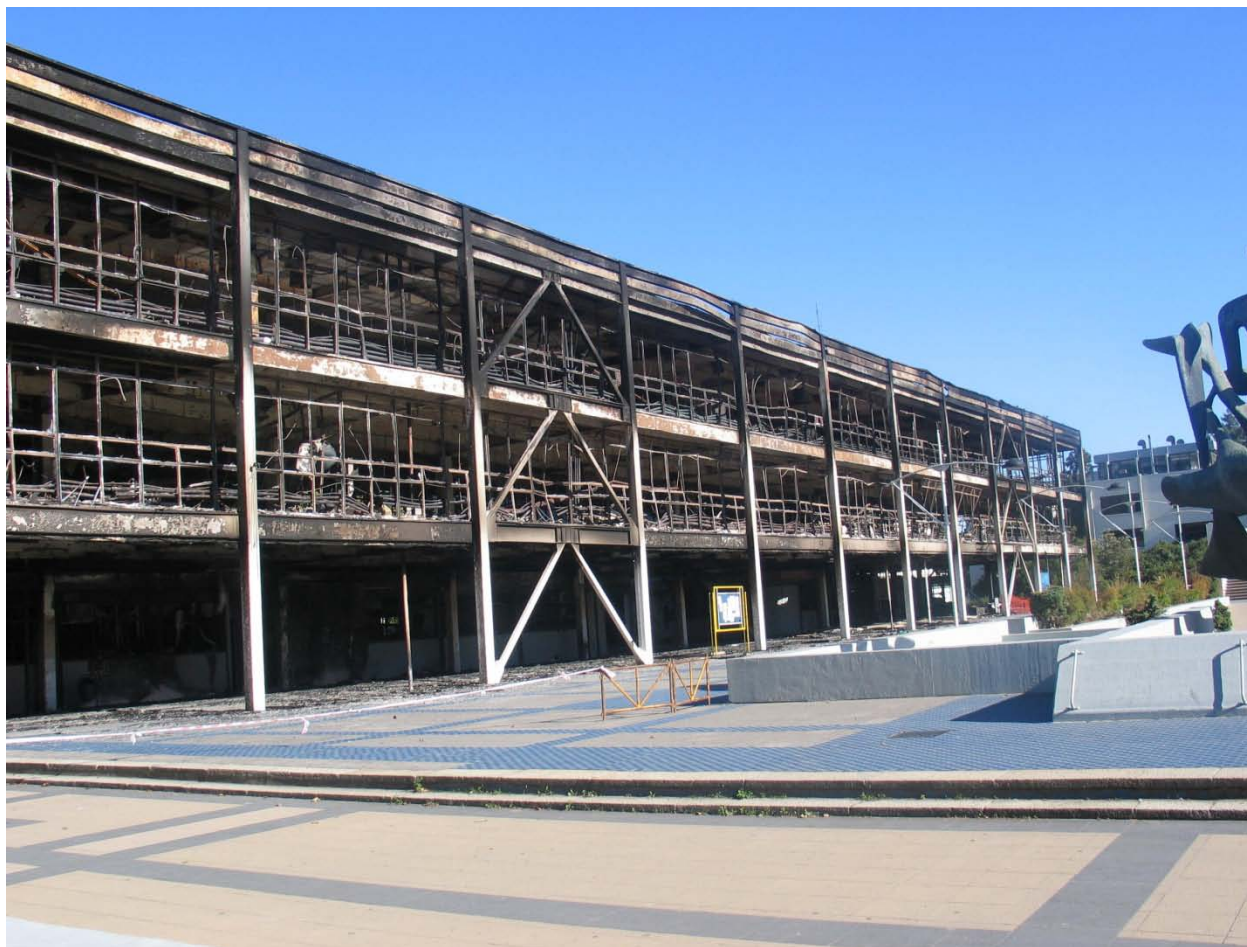
Figure 6.5.4.1-4 Fire destroyed the chemistry building containing the entire chemistry department at the University of Concepción in the 2010 magnitude-8.8 Chile Earthquake; fire exacerbated by the presence of hazardous chemicals (Photo courtesy of Bill Holmes, Rutherford & Chekene).

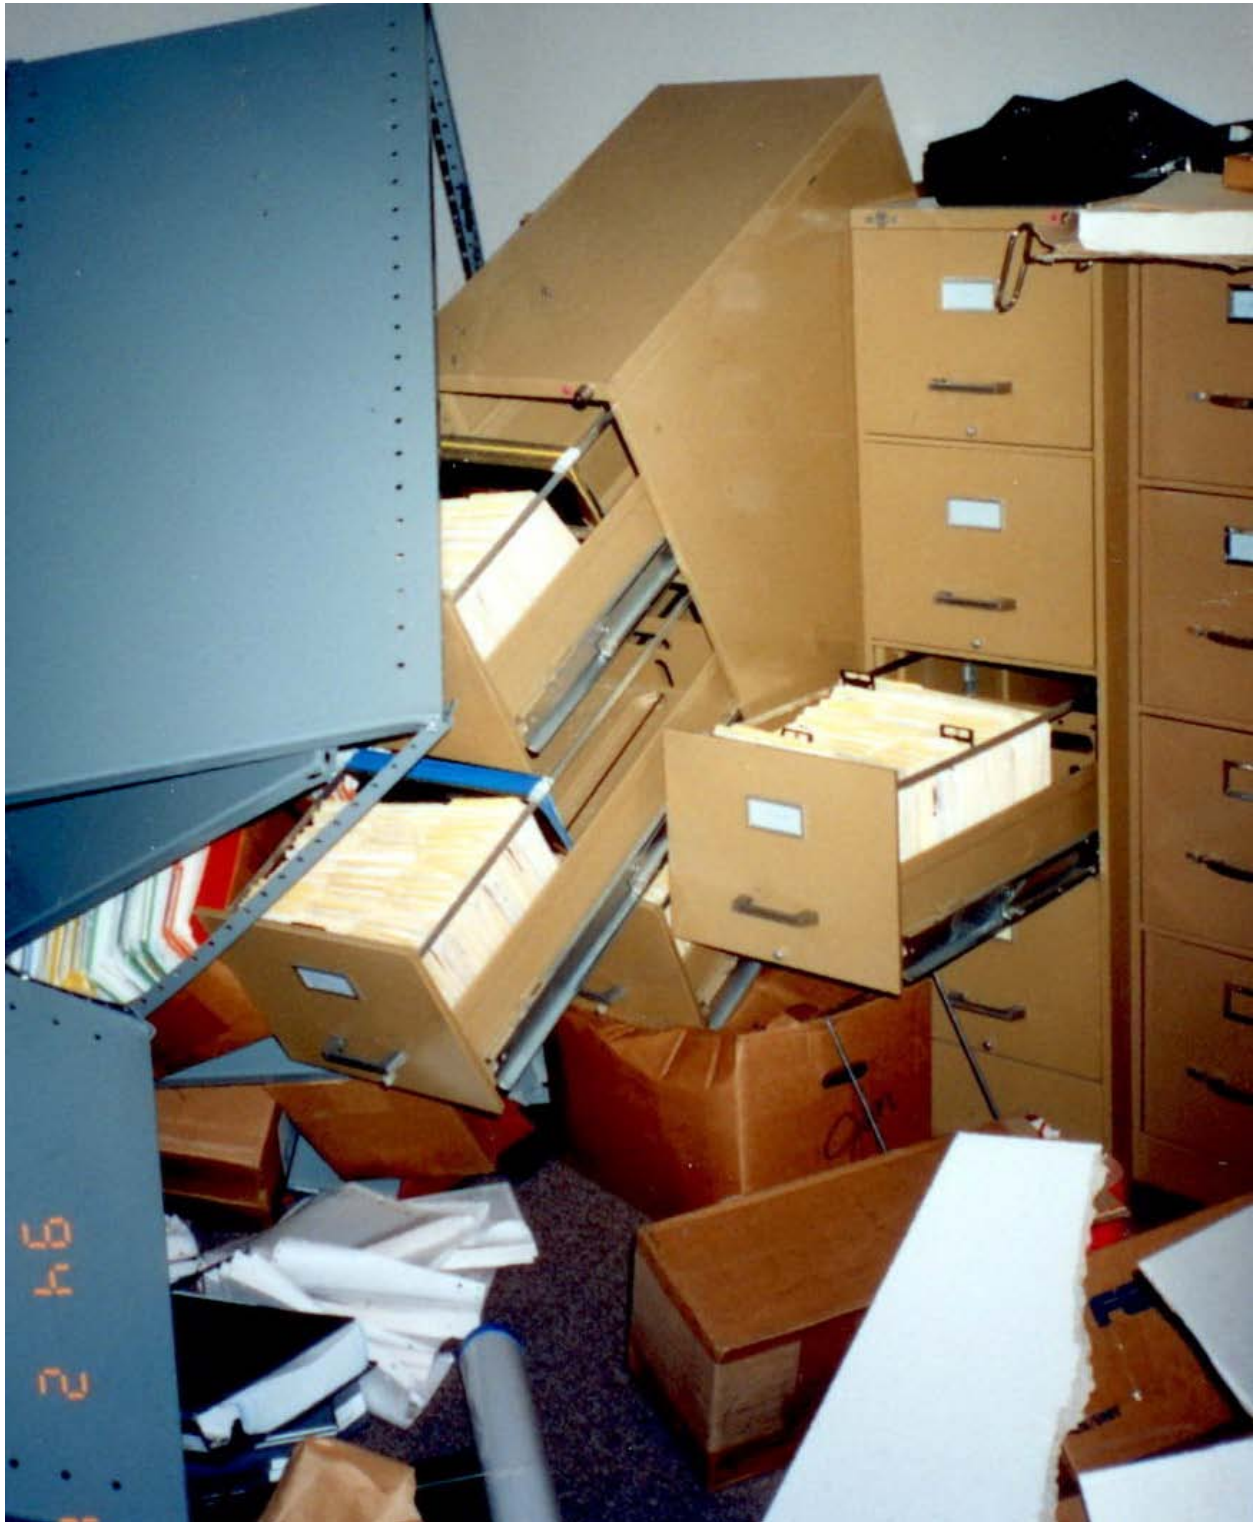
Figure 6.5.5.1-1 Failure of file cabinets in the 1994 magnitude-6.7 Northridge Earthquake (Photo courtesy of Wiss, Janney, Elstner Associates).

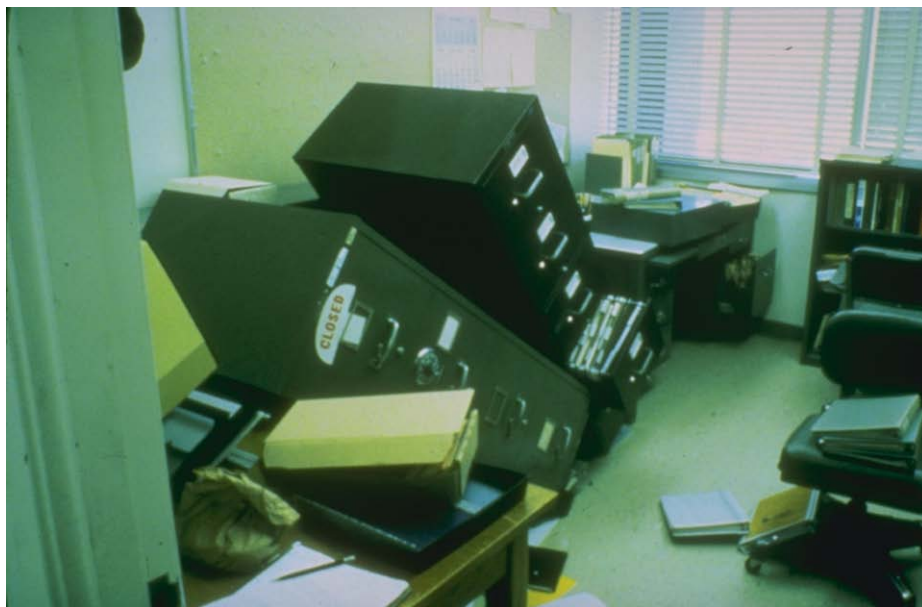
Figure 6.5.5.1-2 Tipped filing cabinets and other office equipment at the Lawrence Livermore Lab, California (NGDC, 2009).

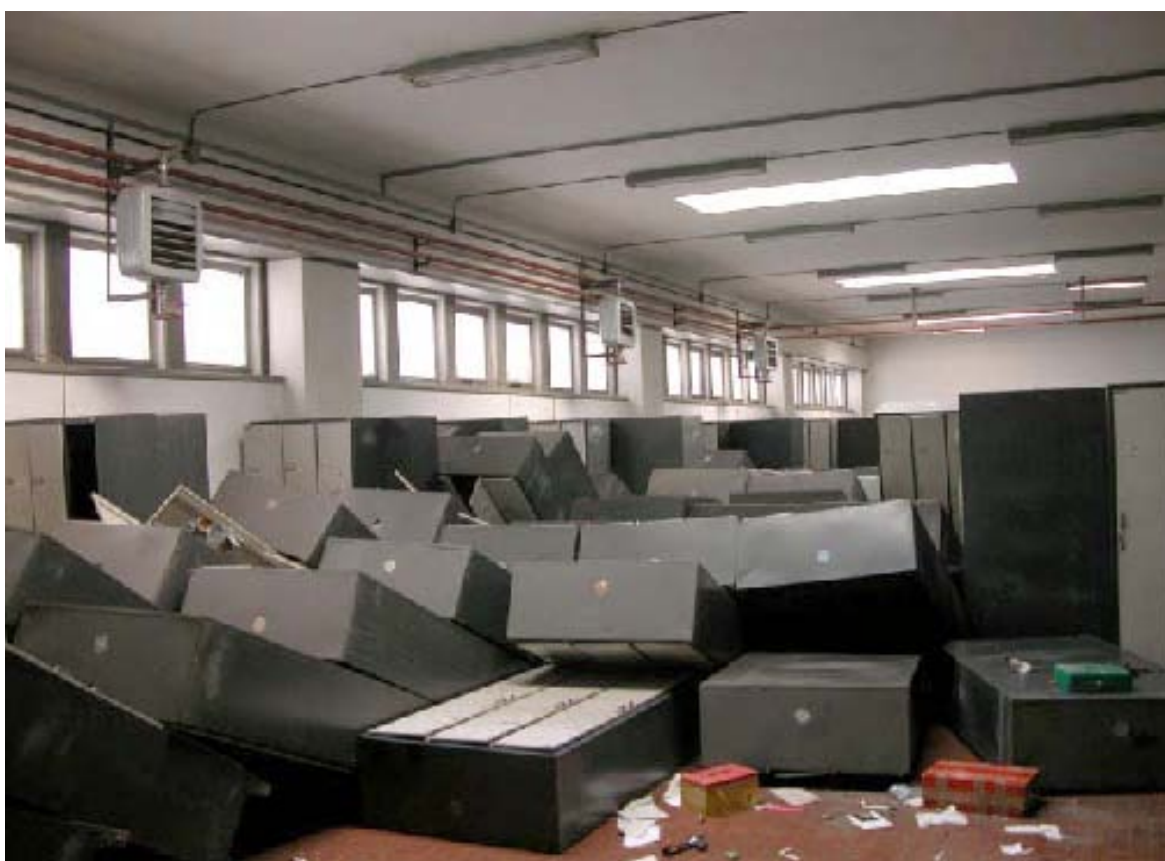
Figure 6.5.5.1-3 Unanchored cabinets toppled in the 1994 Northridge Earthquake (Photo courtesy of Wiss, Janney, Elstner)
